CASE
STUDY

REDI-LINER CERAMIC

MODULAR LINING SYSTEM

PRODUCT:	Redi-Liner Polyurethane & Redi-Liner Ceramic
PRODUCT CATEGORY:	Flow & Anti-Wear
LOCATION:	Wagga Wagga, New South Wales, Australia
CONVEYED MATERIAL:	1½" (30mm), crushed river rock
PREVIOUS WEAR LINER INSTALLED:	CC 1500 Chromium Carbide
PREVIOUS WEAR LINER LIFE:	6 months
CURRENT WEAR LINER INSTALLED:	Redi-Liner Ceramic G83A
CURRENT WEAR LINER LIFE:	2½ years
CURRENT WEAR:	30%
INSTALLATION DATE:	January 2011
LAST INSPECTION DATE:	May 2013

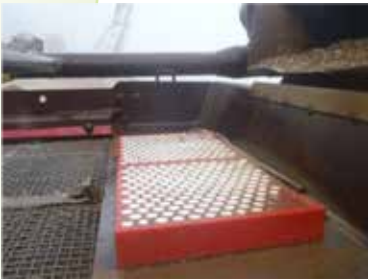
2011 photo of Redi-Liner ceramic in place after 6.5 months

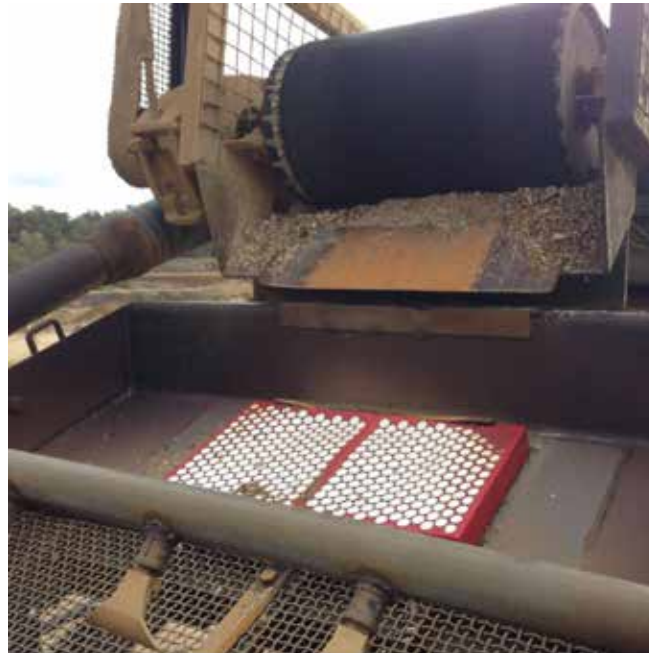
2013 photo of Redi-Liner ceramic lining still in place after 2 years and 4 months of constant use
