CASE
STUDY

REDI-LINER CERAMIC

MODULAR LINING SYSTEM

PRODUCT:	Redi-Liner Polyurethane & Redi-Liner Ceramic
PRODUCT CATEGORY:	Flow & Anti-Wear
LOCATION:	Rail Terminal, St. Peter's, Sydney, Australia
CONVEYED MATERIAL:	Basalt rock, ¾" - 1½" (20mm - 30mm), crushed and screened
EXISTING WEAR LINER INSTALLED:	Abrasion-resistant steel plate
RATE:	700 tons per hour, 22 foot (7m) drop
INSTALLATION DATE:	18 months to date

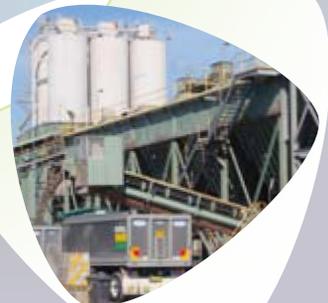
The main problem our customer had at St Peters is the necessity to keep noise levels down. It's essentially an urban area, being only 4¼ miles (7km) from Sydney's CBD. So they wanted to find a different type of chute liner to replace their existing steel liner, one that absorbed the noise, and at the same time weighed lighter and would last longer.

Follow-up feedback from our customer tells us that they are extremely satisfied with the performance of both of the Redi-Liners. Since fitting them not only has the noise levels reduced dramatically, which was their primary need at St. Peters, but the installation of the panels was very easy. From a maintenance perspective, getting access to confined areas has very specific challenges, let alone the complication of a heavy steel liner.

The wear on the Redi-Liners has been highly satisfactory; even after 18 months constant use there is very little wear on the panels.

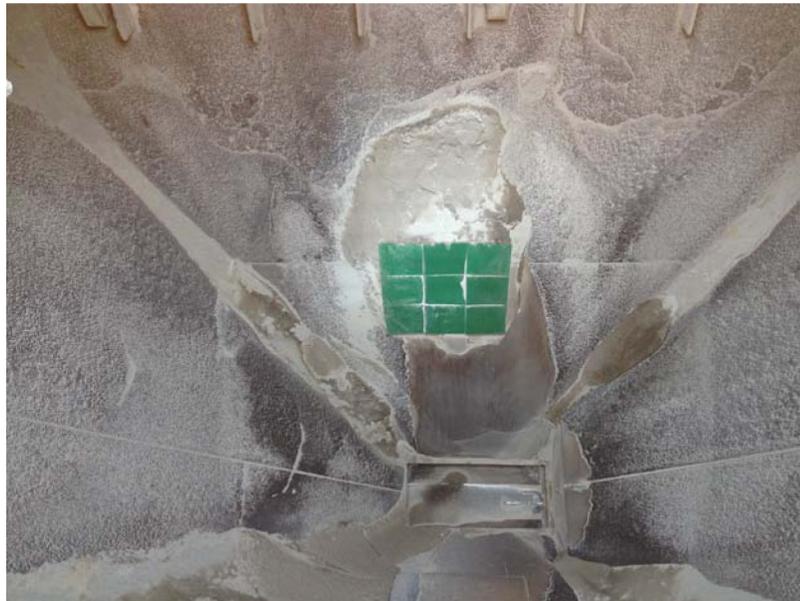
*Redi-Liner Polyurethane in place at the bottom
of the chute of St. Peters rail terminal*
