CASE  
STUDY

# REDI-LINER DUAL DUROMETER CERAMIC MODULAR LINING SYSTEM

<b>PRODUCT:</b>	Redi-Liner Dual Durometer Ceramic
<b>PRODUCT CATEGORY:</b>	Flow & Anti-Wear
<b>LOCATION:</b>	Hill View Quarries, Dromana, Victoria, Australia
<b>CONVEYED MATERIAL:</b>	Granite rock, 15" (400mm)
<b>EXISTING WEAR LINER INSTALLED:</b>	Abrasion-resistant steel plate
<b>RATE:</b>	350 tons per hour, 8 foot (2.5m) drop
<b>INSTALLATION DATE:</b>	14 months to date

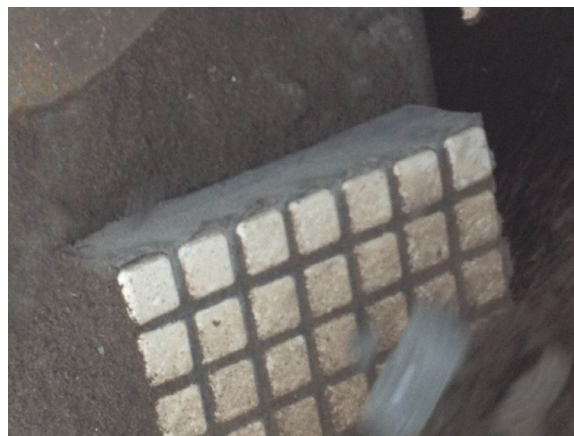
*Redi-Liner Polyurethane in place at the bottom of the chute at the Hill View Quarries*

**RESOLUTION:** First, a solid 2" polyurethane wear panel was tested, which lasted 3 days.

Next, an Argonics dual durometer ceramic Redi-Liner panel was tested. This 12" x 12" x 4" panel was made up of a 63 Shore A durometer bottom with a 93 Shore A durometer top, with 1½" ceramic cubes. This panel has lasted 14 months.
