CASE
STUDY

ERASER™
PRIMARY BELT CLEANING SYSTEM

PRODUCT:	Eraser™ Primary Belt Cleaning System
PRODUCT CATEGORY:	Belt Cleaning System Products
LOCATION:	Golden Grove, South Australia
CONVEYED MATERIALS:	Clay Brick
INSTALLATION DATE:	June 2013

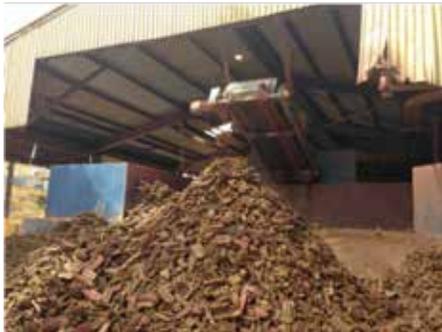
Photo of the Eraser Primary Belt Cleaner System, installed at the customer's brickworks premises in Golden Grove, South Australia.

After consultation with one of our sales engineers to better understand the site and conveyor structure, it was agreed that the best option was to install an Eraser Primary Belt Cleaning System at the run-off end of the conveyor. Given the height and restricted access at the run-off point, the Eraser's unique polyurethane self-tensioning Safe Torque™ ratchet would mean it would require minimal ongoing adjustment. As soon as the conveyor was started after the Eraser was installed, the customer's problem was resolved in the following ways:

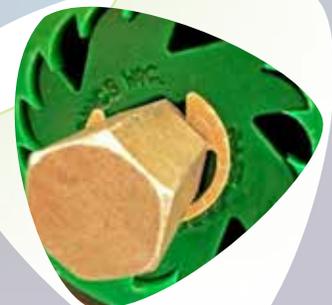
Previously they operated without any primary belt cleaning system. As a result, clay carryback and material spillage would occur along the conveyor, with build-up forming on the return rollers. This could cause belt mistracking and expensive belt edge damage. Extra maintenance and clean-up costs were often required.

- Proven effective cleaning performance
- Rugged mainframe and blade
- Compact mounting footprint
- No rusted springs, hoses, cables, shocks or mudpacked components to deal with
- Uniform tensioning and cleaning pressure
- Brightly colored safety yellow end caps protect from dust and water contamination
- Single pin blade attachment means quick and simple blade change out with less downtime

1. **Immediately, spillage and waste have been reduced** because the Eraser effectively prevents material carryback and also allows for better recycling potential of any waste material;
2. **Immediately, maintenance time and costs have been reduced** because less time each day needs to be scheduled for cleaning up the spillage and washing down the conveyor;
3. **In the future there will be cost savings on the purchase of replacement blades** because the properties of the high-quality engineered polyurethane blade of the Eraser has proven superior durability; also the self-tensioning ratchet reads the belt speed, resulting in accurate and reliable tensioning of the blade edge to the belt;
4. **The belt itself is at less risk of damage** because there is no belt edge damage from the clay build-up;

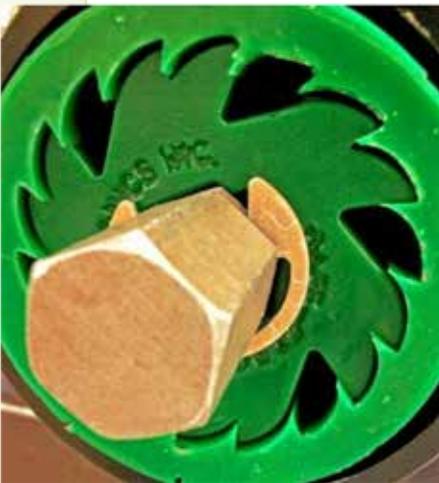
Close-up photo of the Eraser Primary Belt Cleaning System's self-tensioning Safe Torque™ polyurethane ratchet.
