CASE  
STUDY

# REDI-LINER CERAMIC MODULAR LINING SYSTEM

<b>PRODUCT:</b>	Redi-Liner Ceramic Modular Lining System
<b>PRODUCT CATEGORY:</b>	Flow & Anti-Wear
<b>LOCATION:</b>	New Zealand
<b>CONVEYED MATERIAL:</b>	Alluvial Gravel 100 lb/ft <sup>3</sup> (1600 kg/m <sup>3</sup> )
<b>CONVEYOR BELT WIDTH/SPEED:</b>	24" (600mm) Belt Width / 295 feet/min. (1.5m/s)
<b>INSTALLATION DATE:</b>	May 2018

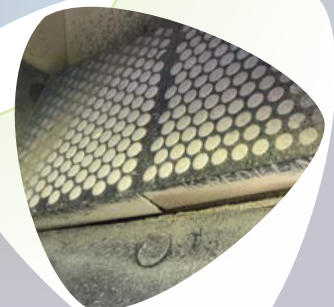
Being a mobile plant means their operation can easily load the plant onto a truck to maximize the productivity of its screening and crushing operation at various locations within a geographical area. Within the mobile plant's high volume transfer zones, the 4mm thick steel plates were left unprotected as new equipment. Over time, grueling screening and crushing production and exposure to the sheer abrasive properties of the transferred quartz-based gravel was the leading contributor to the catch pen wall and chute wearing out from the return belt back into the impactor.

- Maximize mobile plant crushing and screening productivity
- Unprotected steel plates within high impact zones
- Increasing costs and production down-time to replace wear plates every three months

It was recommended that the Redi-Liner ceramic panels be installed within the impact zones of the high wear-prone chute and wall. Clear and effective installation instructions provided to maintenance fitters meant the installation was quick, secure and seamless via the liners' bolt-in system functionality.

Through the impressive Redi-Liner Ceramic installation, the customer reports eliminating the need for patch-up/repair jobs in this high-impact chute area every production shutdown. Wear-prone areas of the operations have been eliminated, with cost savings realized by the quarry operator by not needing to replace the steel plates every three months. Further costs reductions can also be achieved through the replacement of the wear liner where it's most needed instead of replacing the entire liner, and panel rotation flexibility is a key feature of the Redi-Liner available to further extend wear life.

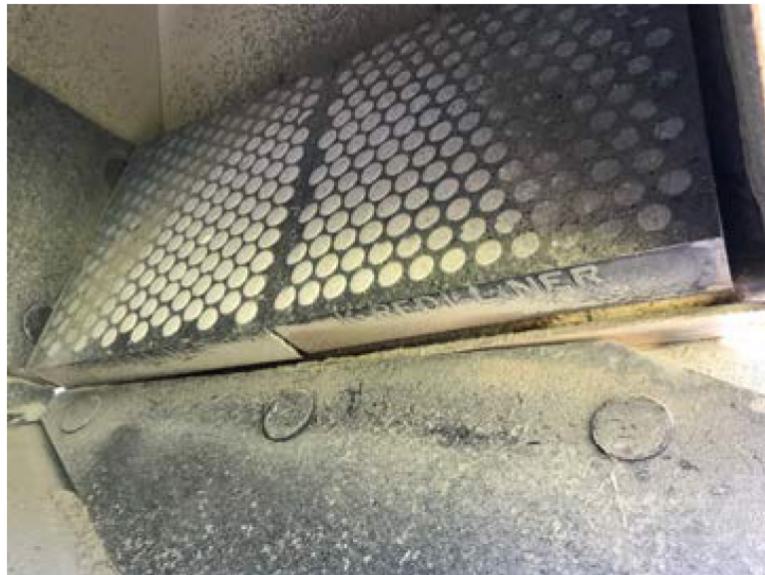
*Redi-Liner Ceramic panels installed*
