CASE
STUDY

REDI-LINER™ CERAMIC
MODULAR LINING SYSTEM

PRODUCT:	Redi-Liner Ceramic Modular Lining System
LOCATION:	Gold mine in Durango, Mexico
CONVEYED MATERIAL:	Crushed ore, ½" (13mm) and smaller
RATE:	1,324 tons per hour
INSTALLATION DATE:	April 2019

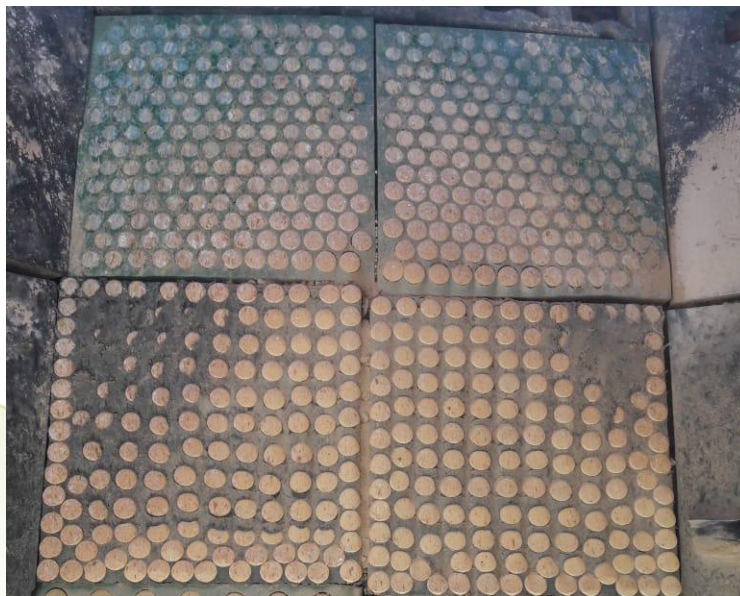
Argonics ceramic panels on top, rubber panels on bottom

A gold mine in Durango, Mexico installed two Argonics Redi-Liner Ceramic panels alongside two rubber ceramic panels in the discharge chute of a transfer conveyor.

After one month, the panels were compared. The Argonics panels showed much less wear than the rubber panels.
